National Transportation Safety Board

Highway Accident Brief

Accident No.: HWY-07-MH-007
Accident Type: School bus bridge override following collision with passenger vehicle
Location: Interstate Highway 565 transition exit ramp 19A, Huntsville, Alabama
Date and Time: November 20, 2006; 10:10 a.m., central standard time

HIGHWAY ACCIDENT BRIEF
NTSB/HAB-09/01

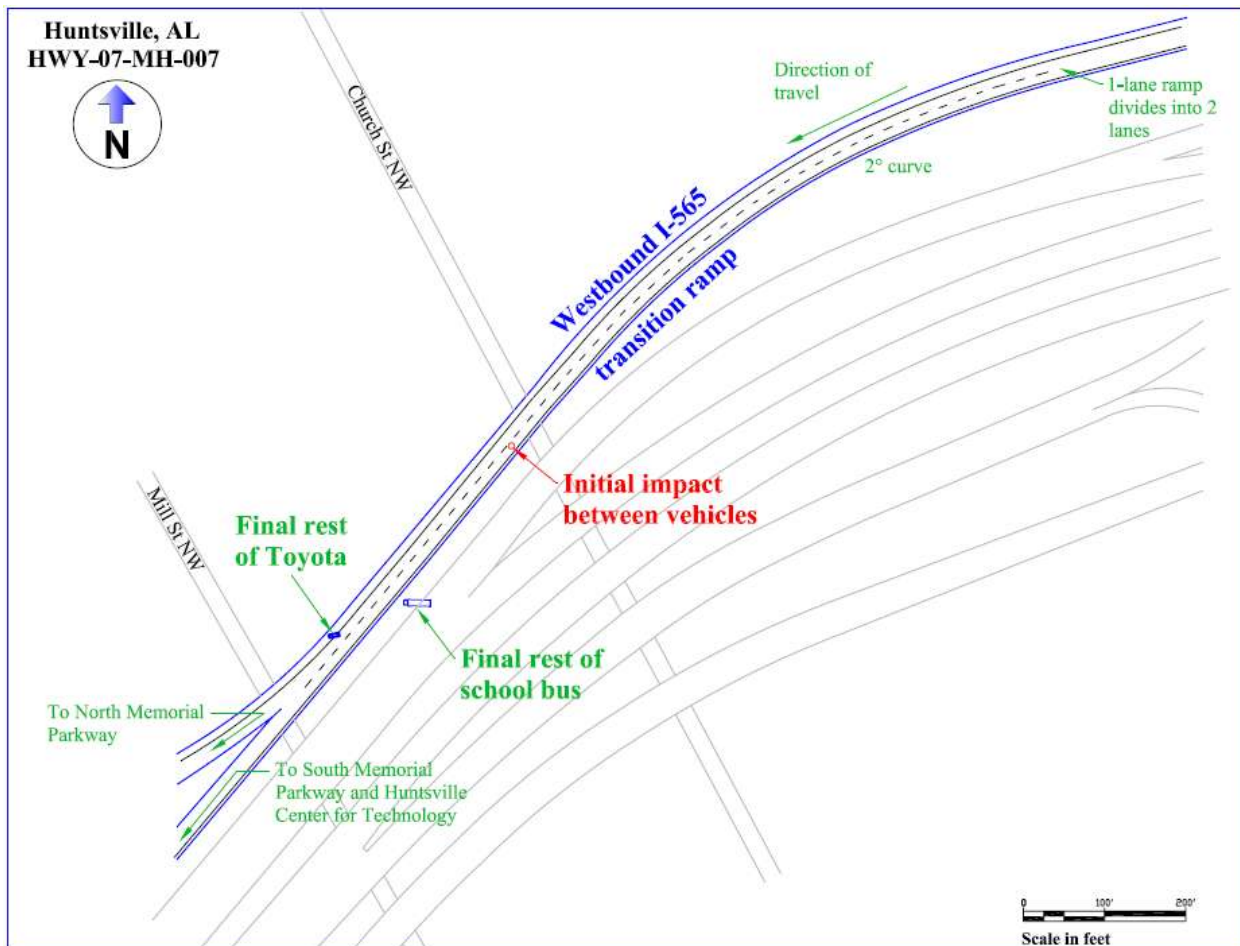
Figure 1. Diagram of westbound I-565 transition ramp, showing point of initial impact between the two accident vehicles, as well as their final rest locations.

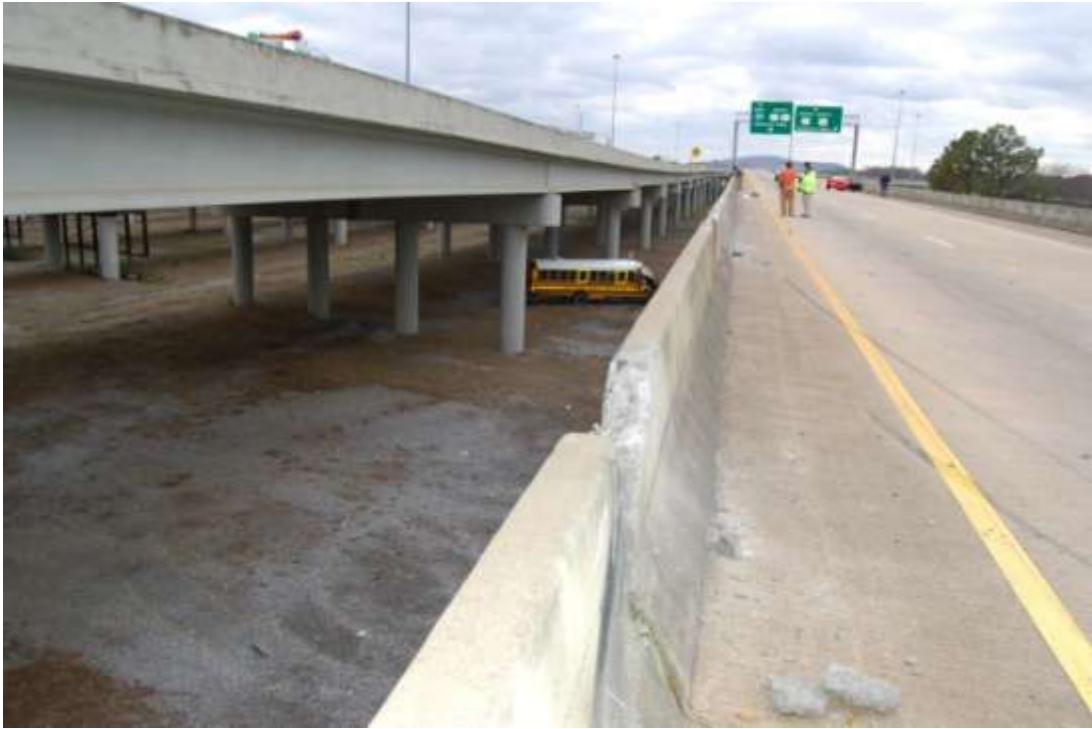
Physical evidence indicated that the school bus climbed and overrode the bridge rail. The school bus driver, who was not wearing his seat belt, was ejected from the bus onto the roadway. The bus continued along the top of the bridge rail for about 117 feet before rolling and falling

Figure 2. Impact damage caused by school bus, westbound I-565 transition ramp bridge rail.

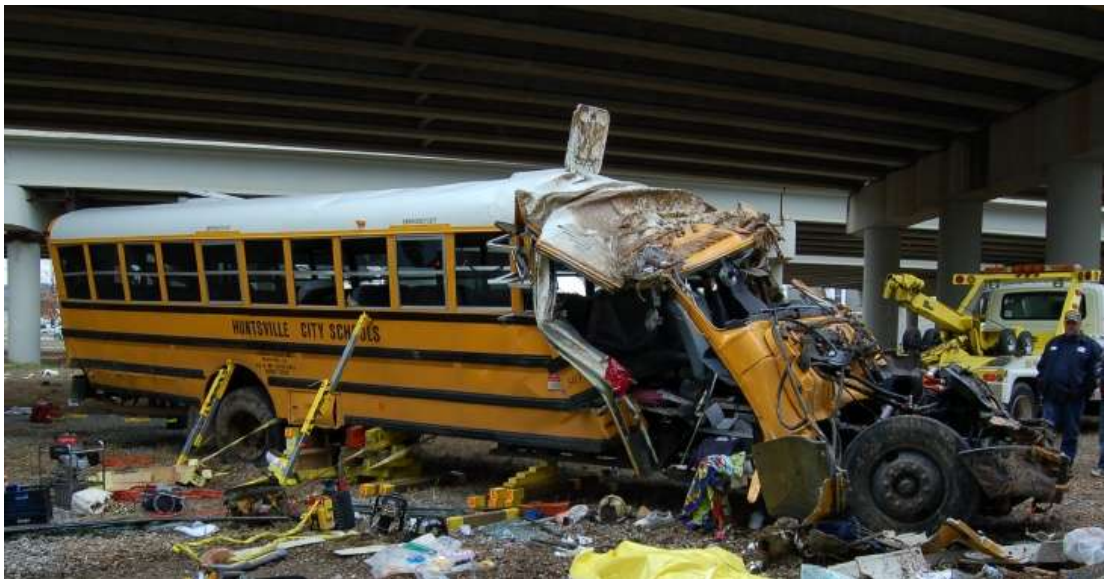
30 feet to a dirt and grass area beneath the ramp. The school bus landed on its front end, rotated clockwise, and came to rest upright on its wheels. (See figures 2 and 3.) Four students in the school bus were killed. The bus driver was seriously injured, and 33 students received minor-to-serious injuries. Three students were not injured.

Figure 3. School bus at final rest position.

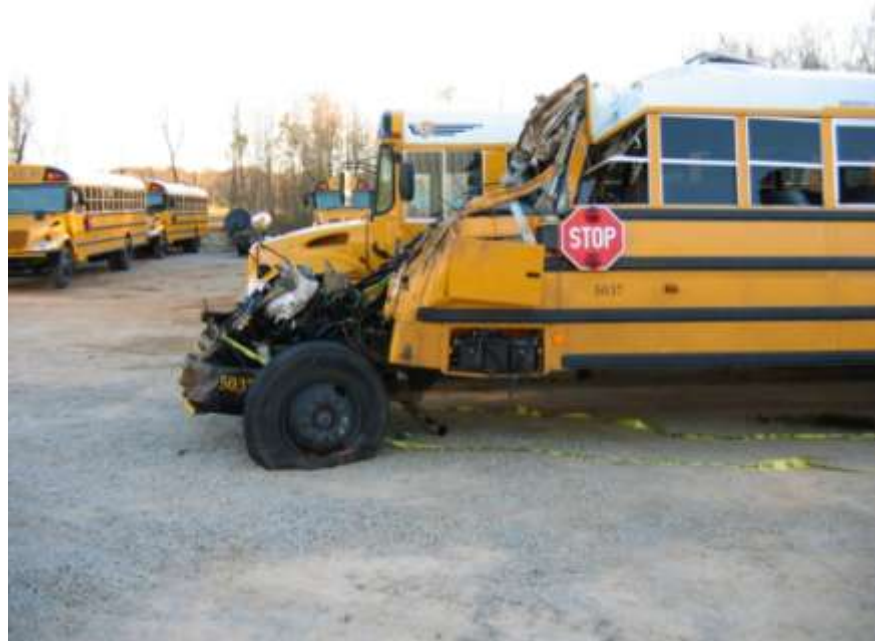
The school bus sustained significant exterior damage to its front end, undercarriage, and roof during its collisions with the Toyota, the bridge rail, and the ground. The damage due to impact with the Toyota extended from the front right corner of the school bus bumper to the right front wheel rim. The damage from the bridge rail ran along the undercarriage and extended almost the entire length of the school bus. The ground impact crushed the front end of the school bus, as well as the front portion of its roof. (See figure 4.) The impact twisted the frame and chassis and caused wrinkled body panels extending to the rear roof area. The twisting of the frame around the rear emergency exit door caused the lower half of the doorframe to be torn away from the body of the bus and caused the top of the rear exit door to bend, allowing the door to spring open. (See figure 5.) The door was bowed inward, and the bottom hinge pin was bowed outward; the top hinge pin was sheared off.

The damage to the interior of the school bus was primarily to the driver seating area and the front loading door. The steering wheel and steering column were crushed downward into the driver seat cushion. The roof crush extended approximately 36 inches into the driver seating area and loading door. The roof also intruded into the first row passenger seating area, though the maximum extent of intrusion could not be determined due to the extensive use of extrication tools and other lifesaving devices within the school bus after the accident.

Figure 4. Extent of damage to front of accident school bus, compared with exemplar school bus.

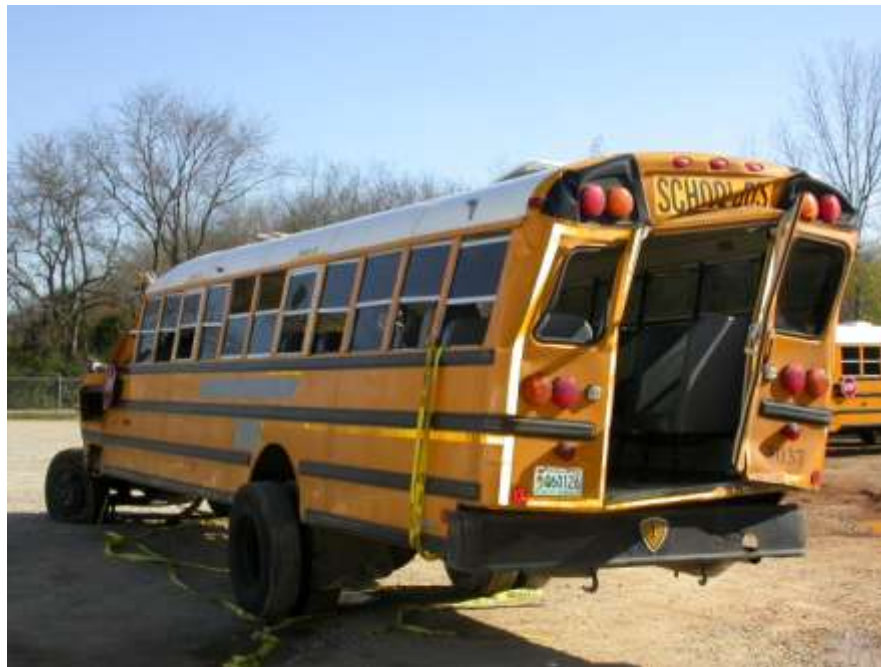
Figure 5. Twisted bus frame and open rear emergency exit door resulting from impact with ground.

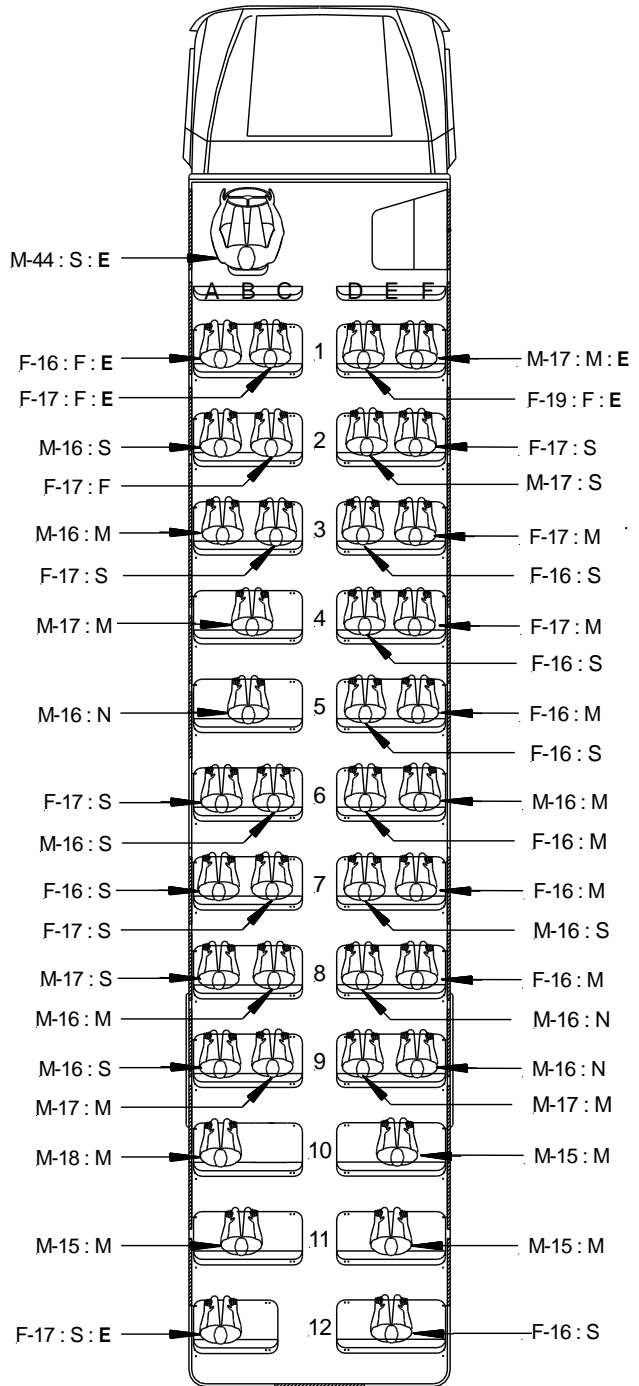
Table 1 summarizes the injuries resulting from the accident, and figure 6 shows the seating positions, ejection status, and injury severity of the school bus passengers. Three of the four fatalities occurred among the front row passengers, and one fatality occurred among the second row passengers. Had the school bus been equipped with lap/shoulder belts, some serious injuries might have been mitigated among occupants seated away from the area of intrusion, such as the fatally injured passenger in the second row and the seriously injured passengers in the rear of the bus, because the belts would have kept these students within their seating compartments during the accident sequence.² However, because it could not be determined whether—at its point of maximum penetration—the school bus roof impinged upon the survivable space of the first row passengers, uncertainty exists as to whether lap/shoulder belts might have prevented the fatalities among the first row passengers.

Figure 6. Seating chart listing gender, age, and injury severity of each bus occupant. Occupants further identified with an "E" were fully or partially ejected from the bus during the accident sequence.

On page 7, figure 6, seating chart, the following corrections are made: (1) the age of the student passenger in row 7, right side, window seat, is corrected to “16,” and the injury code is corrected to “M” for “minor”; and (2) the injury code for the student passenger in row 7, right side, aisle seat, is corrected to “S” for “serious.”
